Manhole Inspection Summary

Manhole # S2111_012MH

Insp Date: **5/5/08 12:06 PM**

Location Address: **2819 hinsdale rd**

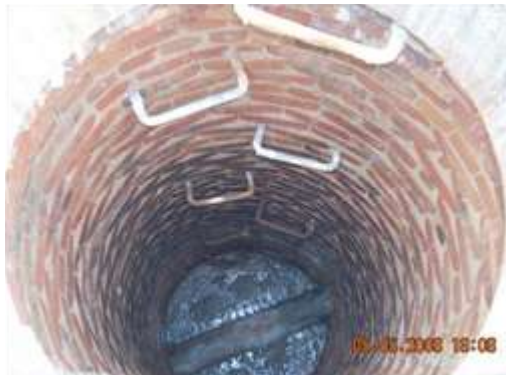
Defect 3

Steps Count: **8** Missing: **0** ☒ **Corroded**

corroded steps

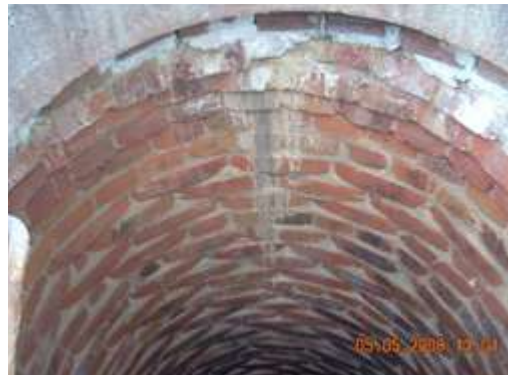
Defect 2

Infiltration: ☐ None ☒ **Joint** ☐ Cracks ☐ Mortar ☐ Roots ☐ Wall

infiltration @ chimney/frame joint

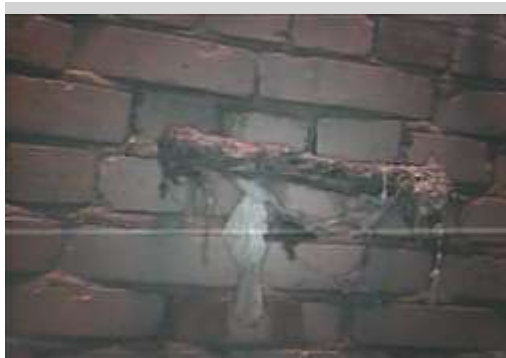
Defect 1

Surcharge ☒ **Evidence Of Surcharge** Depth: **3** (ft.) ☐ Active Surcharge Present

surcharge evidence

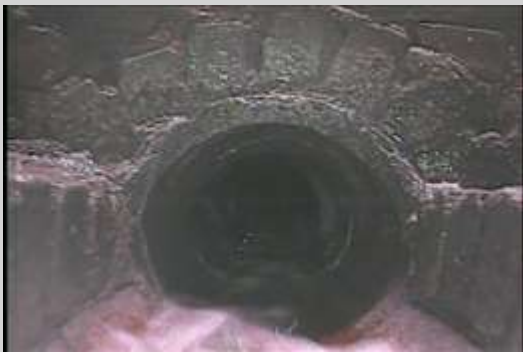
12 O'Clock Outflow

10 in. Circular Gravity Sewer
Pipe Out @ 12 O'Clock

Pipe Height: **10.8** (in.) Rod and Bar (Angled)
Pipe Material: **Clay** ☐ Pipe Lined
Invert Depth: **13.28** (ft.) Flow Characteristics: **Turbulent**
Deposits: ☒ None ☐ Mud ☐ Sludge ☐ Debris ☐ Grease
Silt Depth: **0** (in.) Deposits Extent:
Infiltration: **None** Pipe Seal Cond: **Sound**

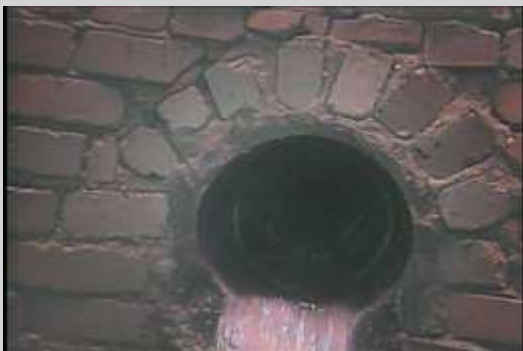
6 O'Clock Inflow

10 in. Circular Gravity Sewer
Pipe In @ 6 O'Clock

Pipe Height: **10.8** (in.) Rod and Bar (Angled)
Pipe Material: **Clay** ☐ Pipe Lined
Invert Depth: **11.57** (ft.) Flow Characteristics: **Turbulent**
Deposits: ☒ None ☐ Mud ☐ Sludge ☐ Debris ☐ Grease
Silt Depth: **0** (in.) Deposits Extent:
Infiltration: **None** Pipe Seal Cond: **Unknown**

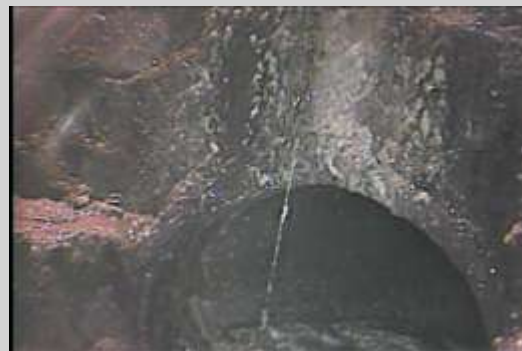
Drop In @ 6 O'Clock

Drop: **Outside** Rod and Bar
Angled: **Yes** Reading: **12.24** (ft.)
Inv Depth: **13.24** (ft.)
Drop Condition: **Clogged**
